Confidential Inspection Report

LOCATED AT:
123 Elm St
San Diego, California 92120

INSPECTED ON:
Friday, July 3, 2020

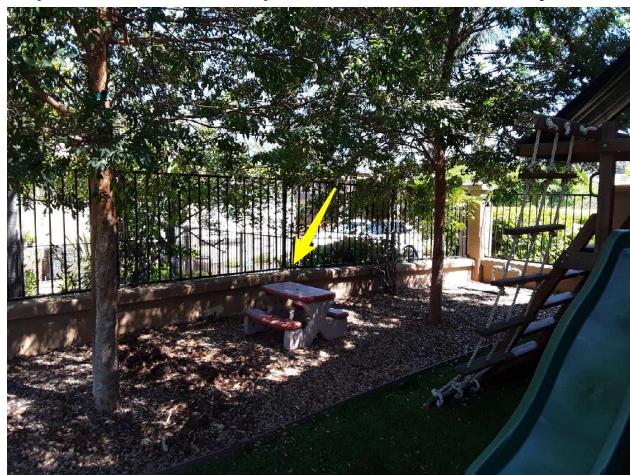
30: There is deterioration/damage to the fencing. We recommend the fencing be monitored and repaired and/or replaced as necessary.

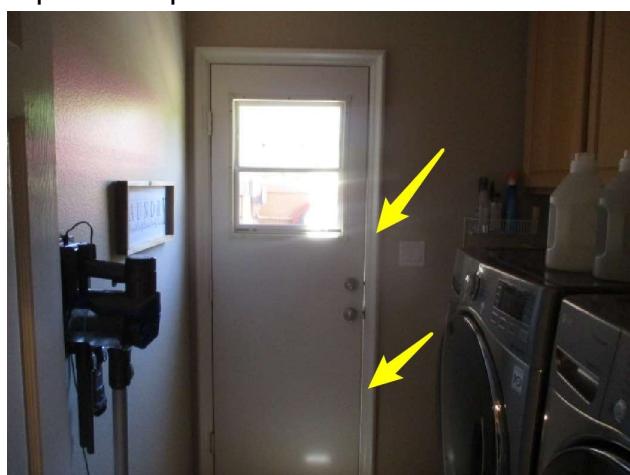
WARN **34:** There is a large gap at the exterior door located at laundry room door that needs to be repaired to prevent moisture intrusion or damage.

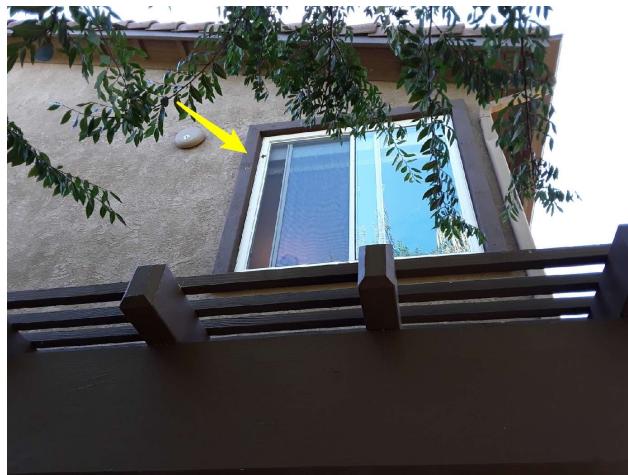
DEFI **35:** One window at the right side exterior is damaged. We recommend it be repaired or replaced.

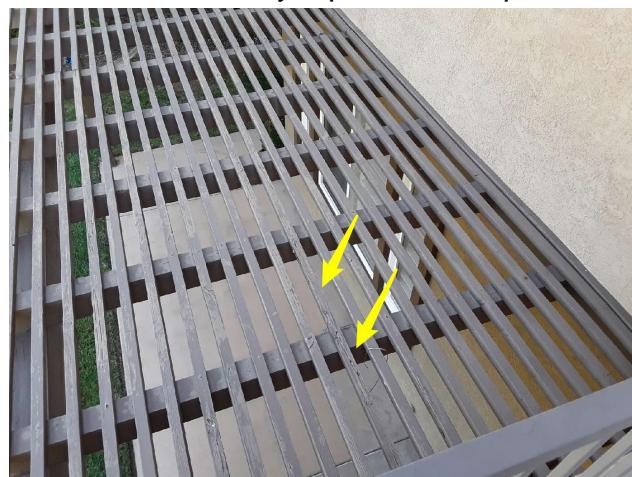
DEFI 47: The patio cover shows signs of wood destroying pest. It is advised that the home be further evaluated by a pest control professional.

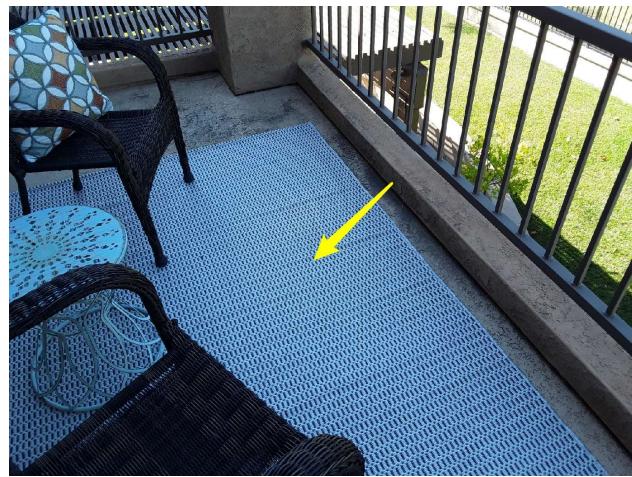
WARN 48: The walking surface of the balcony is spongy or loose. It's advised that the surface be monitored closely for any signs of failure.

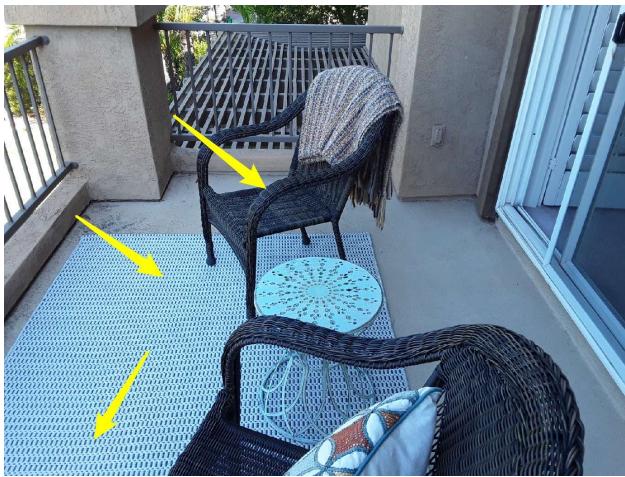
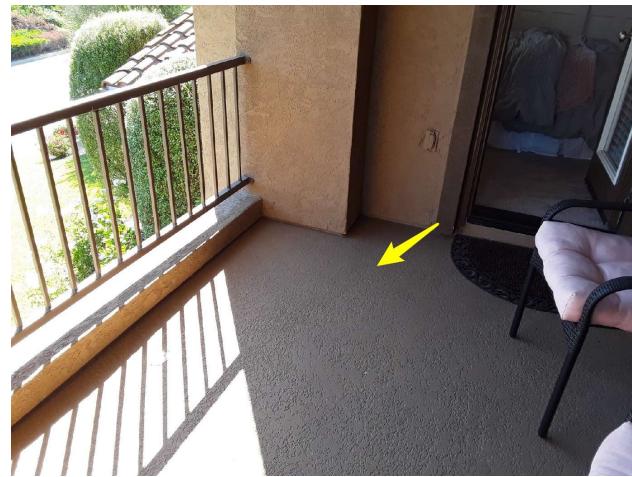
DEFI 51: ELASTOMERIC: The elastomeric coating has split, probably at a seam in the underlying plywood substrate. We recommend the coating be patched or replaced to prevent leakage and serious damage to the support structure.

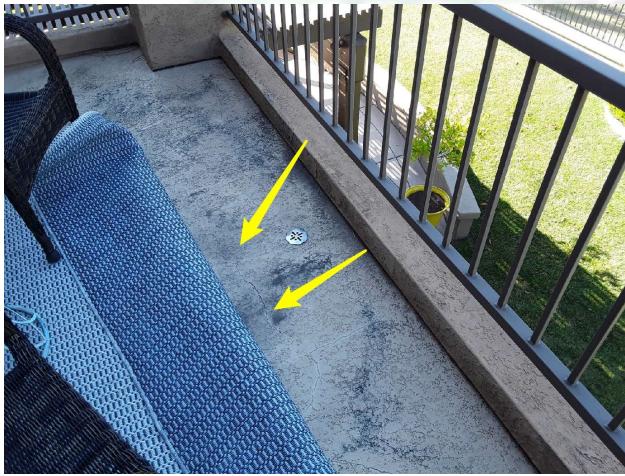
DEFI 52: ELASTOMERIC: There is surface damage to the balcony that needs to be repaired to prevent moisture intrusion or damage to the under balcony area.

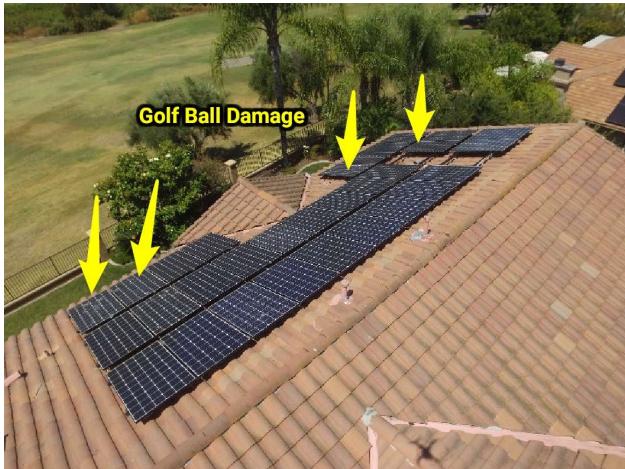
DEFI **89:** Testing the operation of the solar collectors is beyond the scope of this inspection. However, the collectors are damaged broken glass or broken panels. The solar panels need to be further evaluated by an appropriate qualified professional.

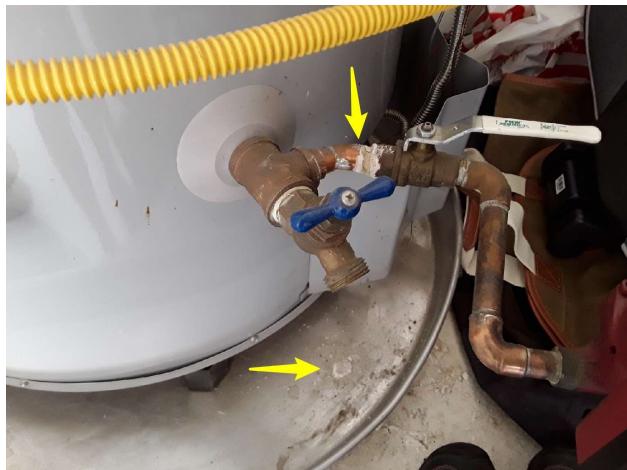
158: INLET/OUTLET: The water connections are corroded and leaking. We recommend they be replaced.

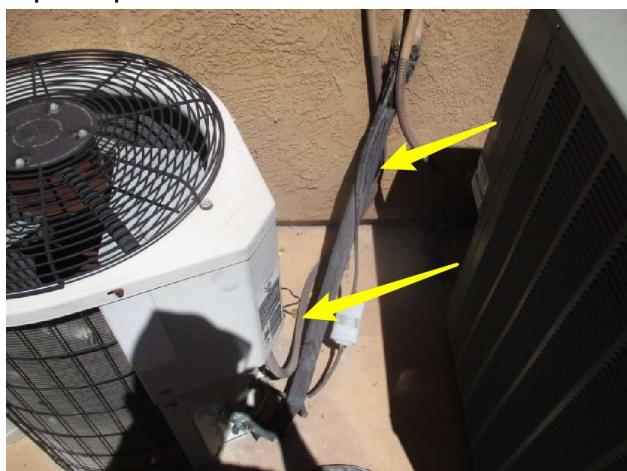
UPG 239: The refrigerant lines at the Air conditioning condenser should be wrapped with a UV tape to prevent deterioration.

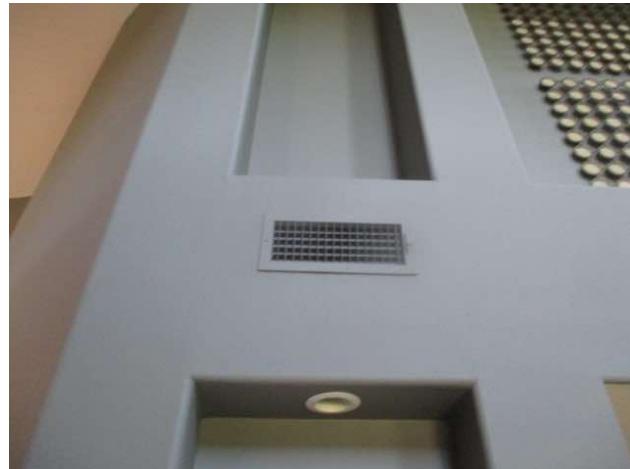
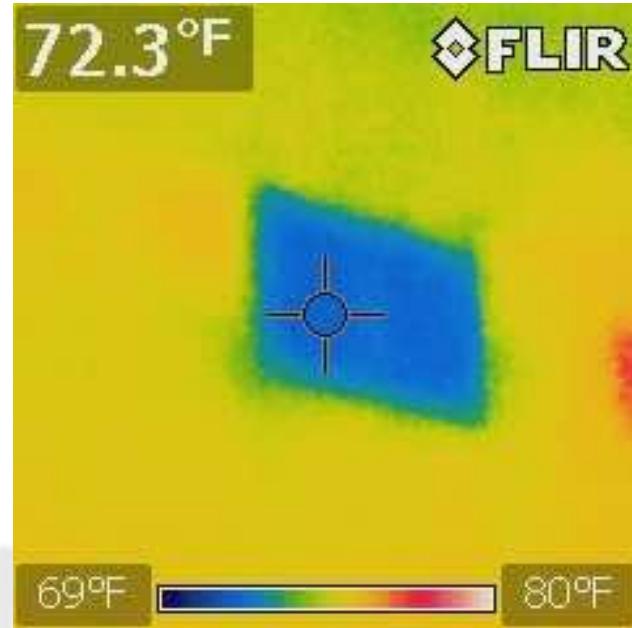
WARN 245: The cooling system did not have an appreciable temperature split of the air entering the system and the air coming out of the register vents. Further evaluation is needed by an appropriate qualified professional.

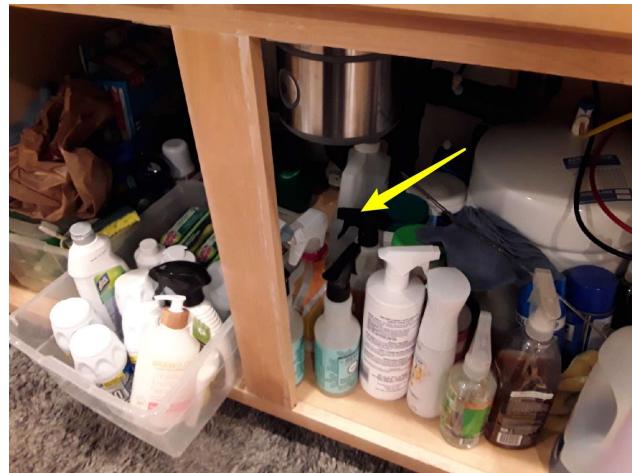
DEFI 337: The cabinet has signs of water damage and needs to be repaired or replaced. It is also advised that the surrounding area be further evaluated for any other water related issues.

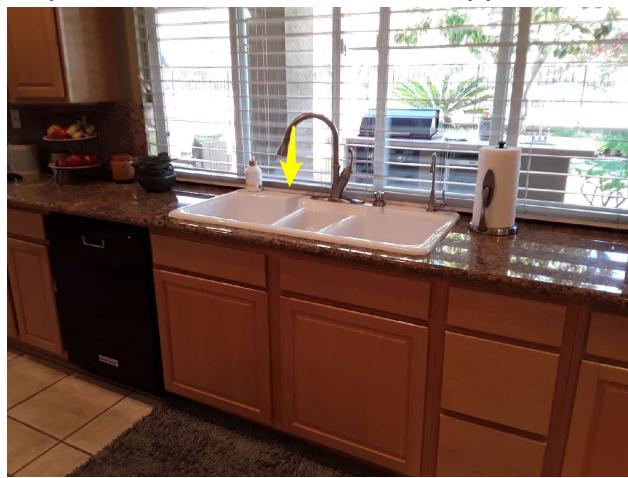
UPG 353: The dishwasher drain lacks an air-gap, as required by present standards. This condition indicates installation by non-professionals and/or a lack of building permits and inspection. We recommend an approved air-gap be installed.

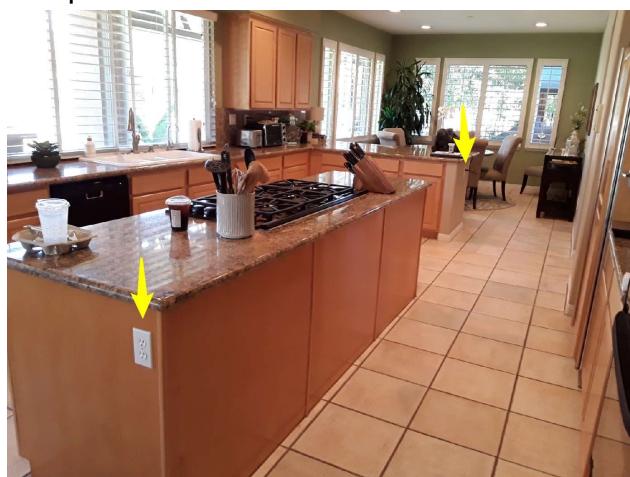
UPG 357: GFCI PROTECTION: GFCI protection was not found at all countertop receptacles even though this was not mandatory at the time of construction. We recommend upgrading in compliance with current standards.

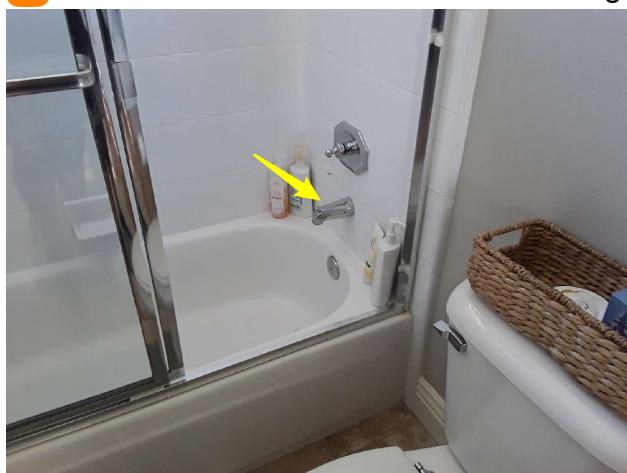
DEFI **390:** The shower/tub diverter is missing and/or damaged. We recommend repair.

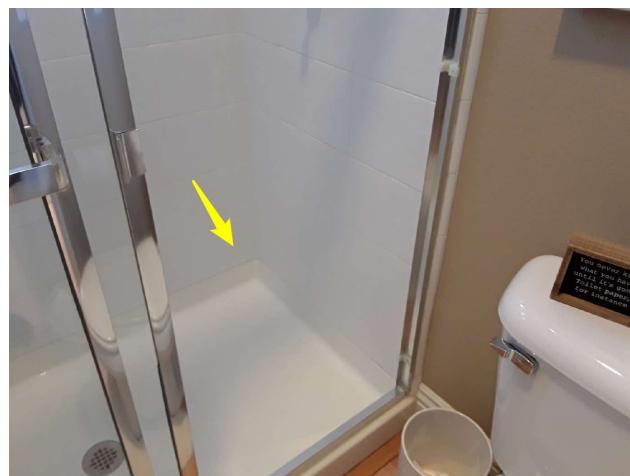
409: There are cracked tiles in the shower. The cracks appear to be of a cosmetic nature only. No action is indicated.

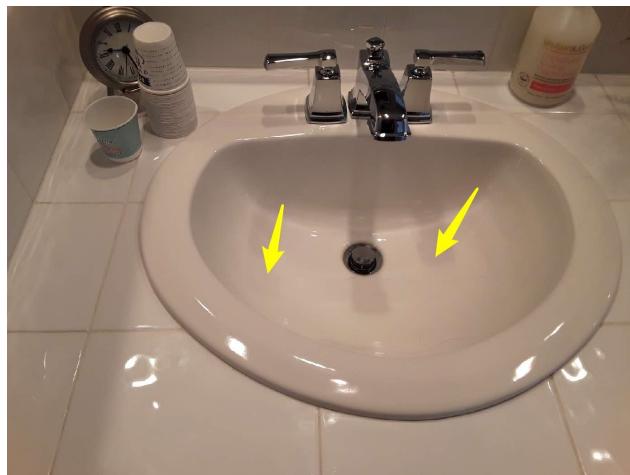
WARN 415: The sink is cracked but not currently leaking. It should be monitored and replaced if leakage occurs.

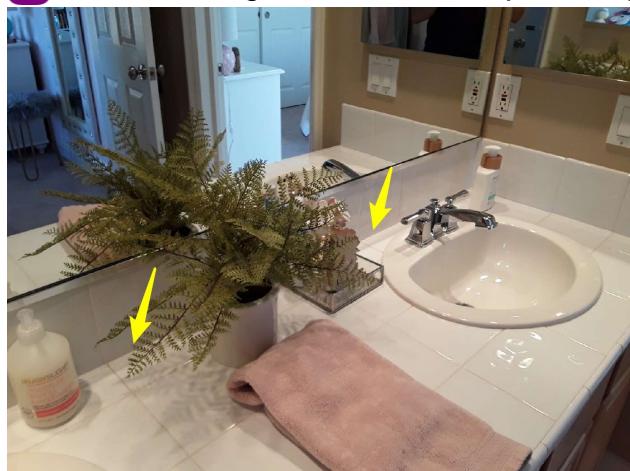
HAND 422: Caulking needed at backsplash to prevent moisture intrusion or damage.

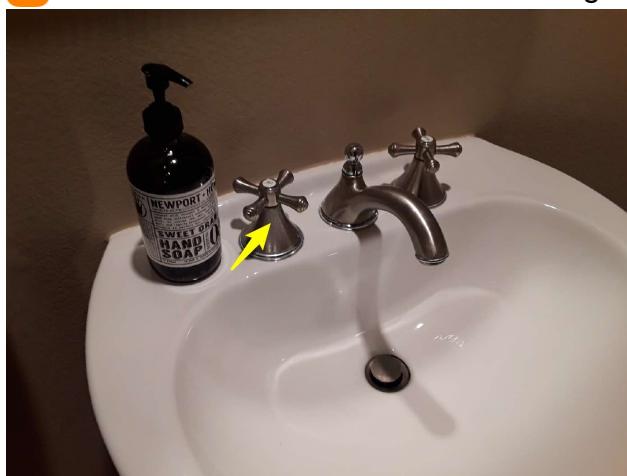
DEFI 428: The sink faucet handle is leaking. We recommend that it be repaired or replaced.

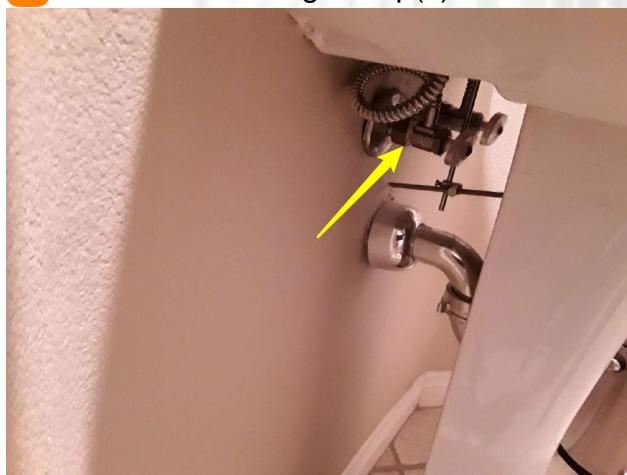
DEFI 431: The sink angle stop(s) have corrosion and need to be serviced.

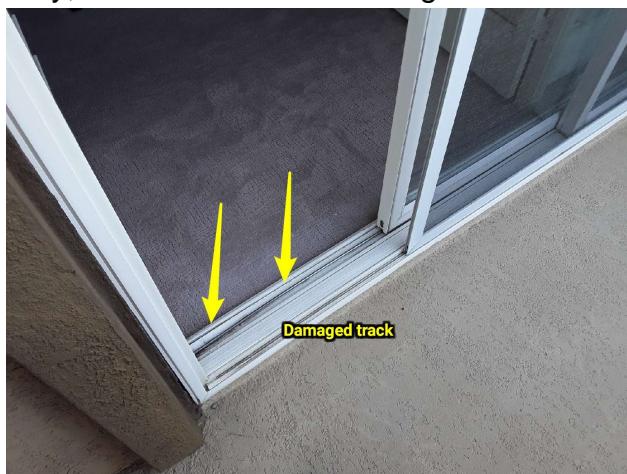
DEFI 438: SLIDING: The sliding door does not operate properly, indicating the track is misaligned, dirty, or the wheels are damaged. We recommend repair or replacement.

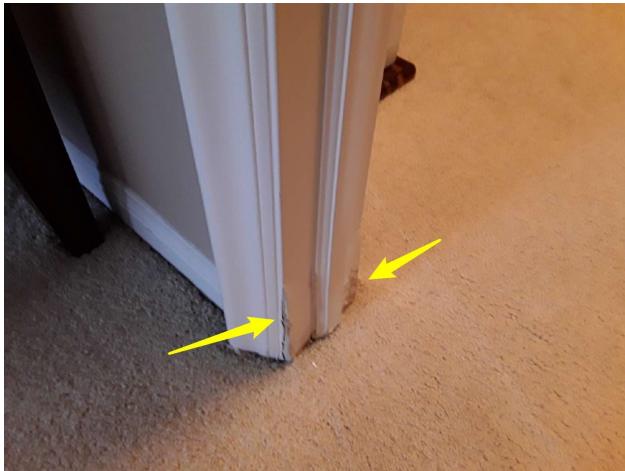
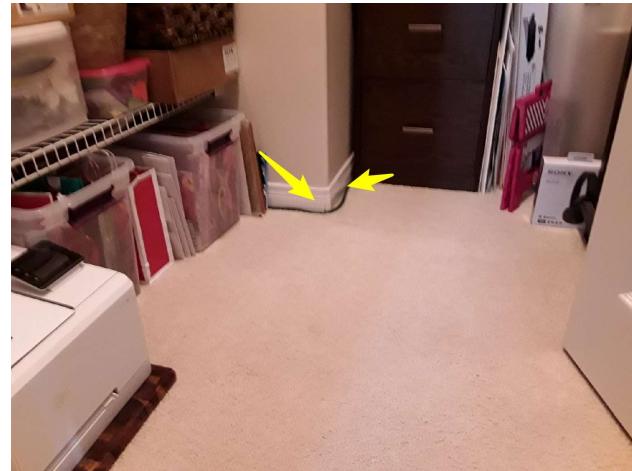
DEFI 469: The walls are damaged at the bedroom closet baseboard. We recommend repair or refinishing.

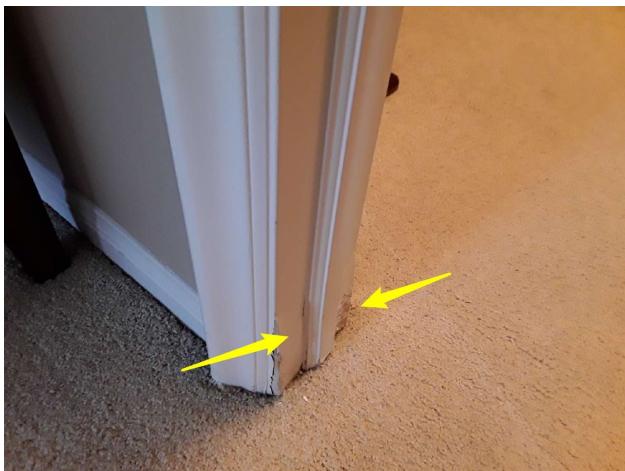
DEFI 470: We noted water staining and minor surface damage. The source of the moisture should be identified and corrected, and the surface prepared and refinished to restore its appearance.

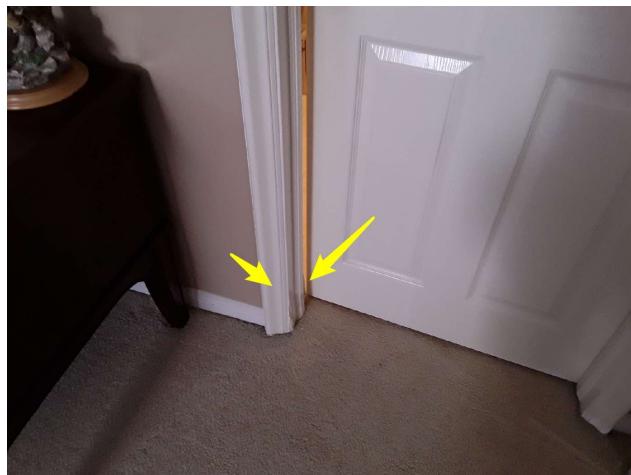
HAND **474:** The closet door rubs on the frame. We recommend it be planed or sanded for smoother operation.

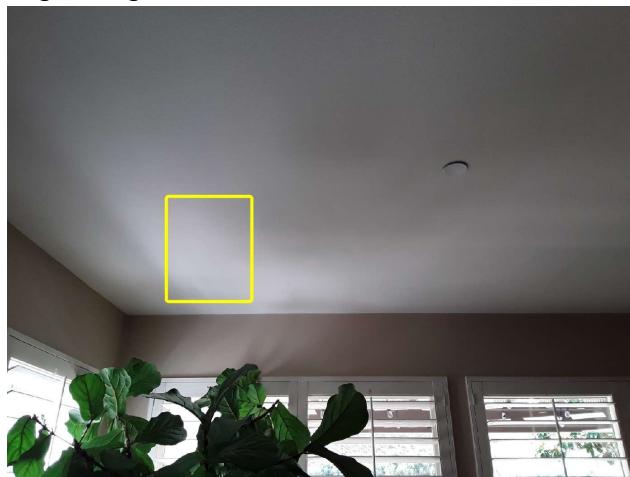
491: There is evidence of patching to the ceiling. It is advised that further inquiry be made regarding this condition.

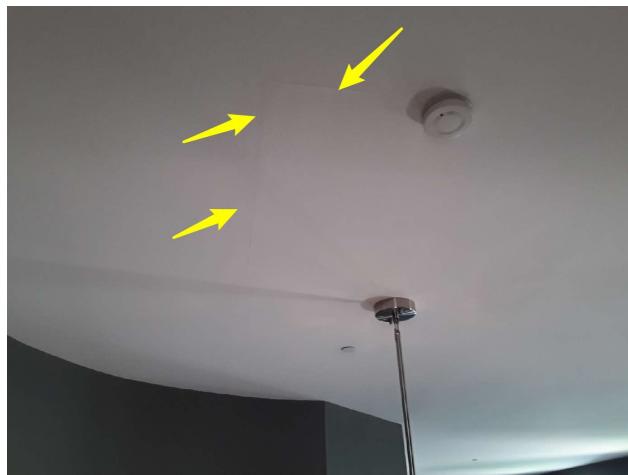
503: There are minor ceiling cracks. This type of cracking in this material is common and does not indicate a structural deficiency. These can be patched, prepared and finished in the course of routine maintenance.

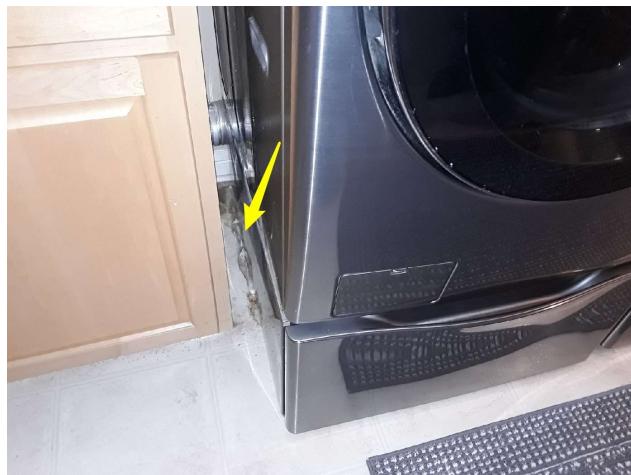
DEFI **514:** VINYL: The vinyl floor covering is damaged at the laundry room . We recommend it be repaired.

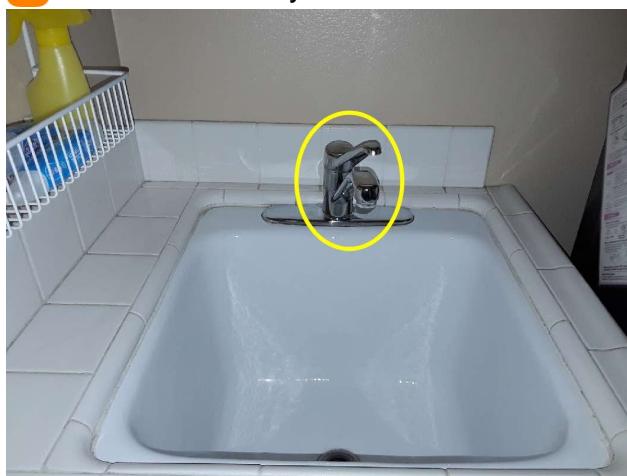
DEFI **520:** The laundry sink faucet is hard to turn needs repair.

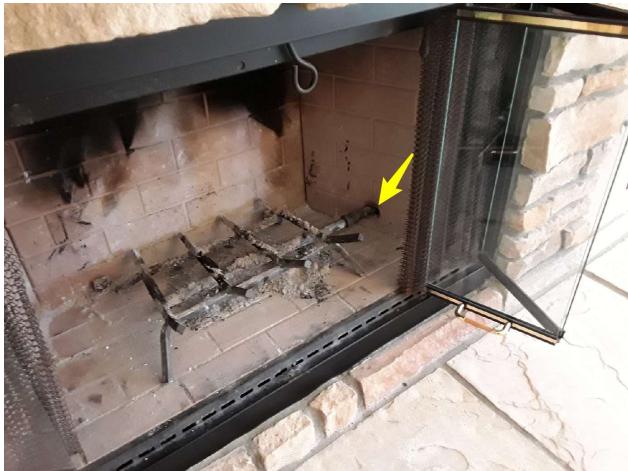
SAFE 532: FIREBOX: The gas line at the firebox needs to be sealed with an approved fire rated caulk.

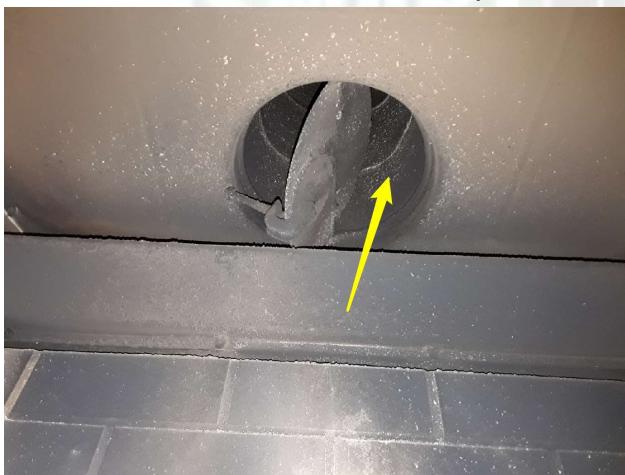
WARN 535: CHIMNEY: We were not able to fully evaluate the fireplace and chimney because of the build-up of soot and creosote. We recommend the flue be cleaned to remove accumulated soot and creosote, and that further inspection be accomplished at that time.

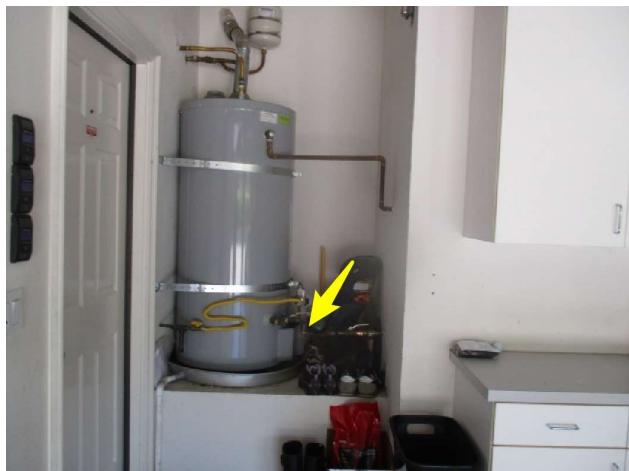
WARN **543:** Mold and mildew have built up on the exposed surfaces. We recommend these surfaces be thoroughly cleaned and chemically treated to remove the growth. Further evaluation is needed by a mold and moisture professional.

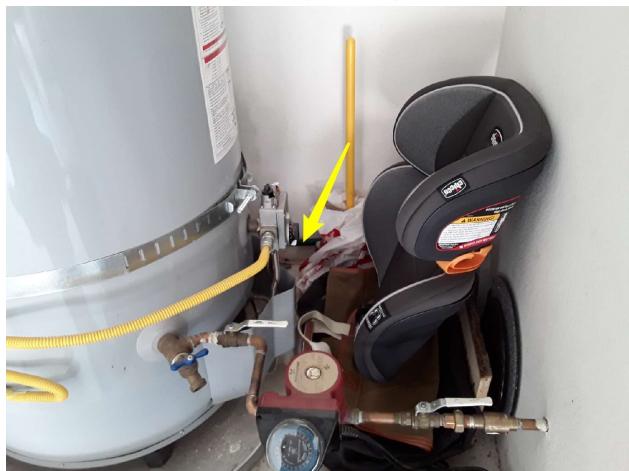
DEFI **544:** We noted water stains on the wall at the water heater , but were unable to identify if the source was still active. We recommend inquiries of the owner and/or occupant, who may have further knowledge regarding their source and whether corrective repairs have been made.

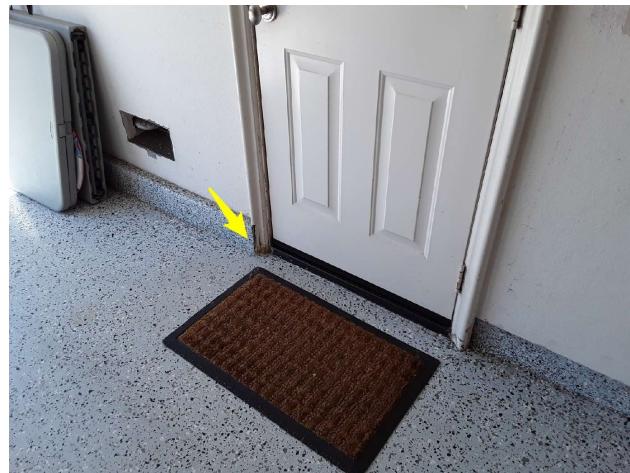
WARN 548: EXTERIOR: There is water staining around the exterior door. We recommend the source of the moisture be identified and corrective action be taken, if necessary.
