# HOME INSPECTION REPORT

For The Property Located At  
**123 Elm St, Rancho Santa Fe, CA 92067**

Smart Home Inspection  
619 846 5737  
[www.smarthomeinspection.net](http://www.smarthomeinspection.net)

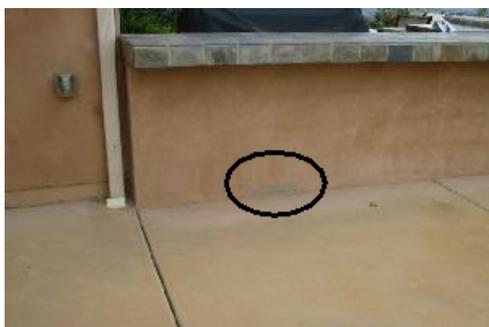
1.16 - DEFICIENT: The stucco wall coverings at the the east side of the residence are damaged and need repair.

1.16 -- DEFICIENT: Wall covering has some damage

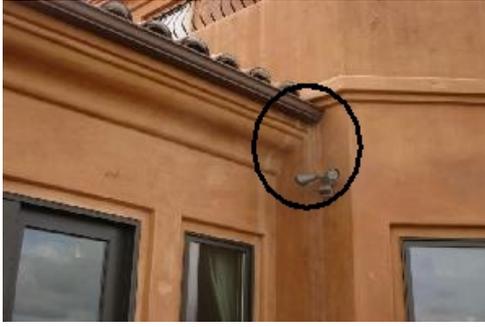
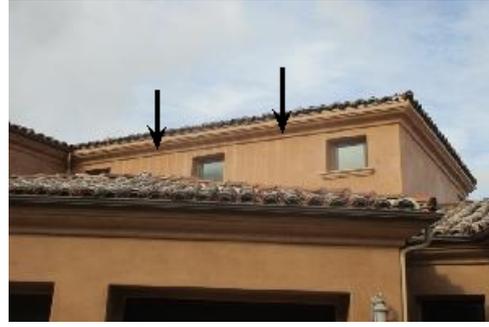
1.19 - PREVENTIVE: There are areas of the homes stucco wall covering that have excess water staining. This could be a result of improper site or roof drainage. It is suggested that this be fixed to prevent premature damage of the stucco and to prevent water intrusion.

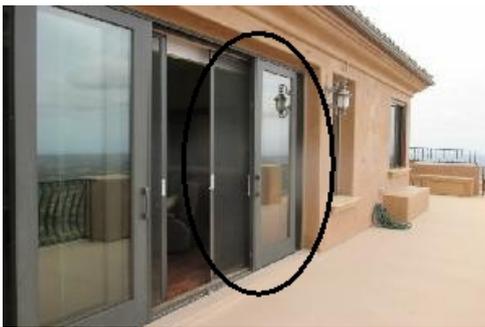
1.24 - DEFICIENT: The sliding screen door at the north side of the residence does not function properly and needs to be serviced.

1.24 -- DEFICIENT: Sliding door screen does not function properly

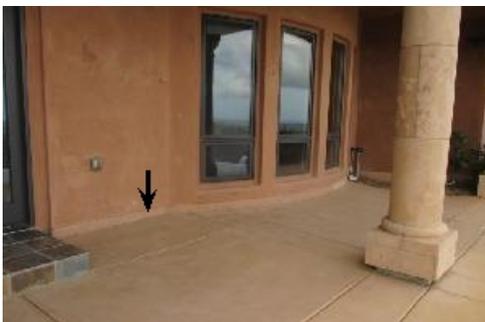
2.9 - MONITOR: There are a few cracks in the slab. These are relatively small (less than 1/4" wide). Generally speaking, cracks that are less than 1/4" wide are not commonly regarded as being signs of structural failure, but can provide access for subterranean termites. In any event, it would be a good idea to monitor the cracks to see if there is additional movement that might necessitate further evaluation by a specialist at a later date.

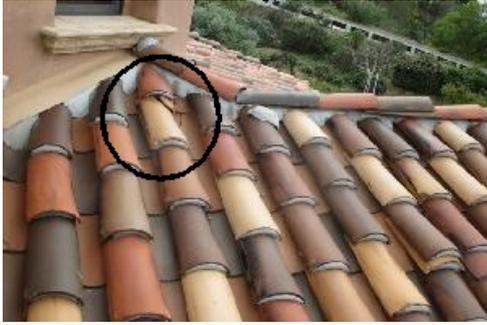
3.5 - DEFICIENT: There are a number cracked tile at the north end of the residence that you should have mended for protection of the felt paper underlayment and to forestall the possibility of leakage.

3.5 -- DEFICIENT: There are broken tile that need replacement

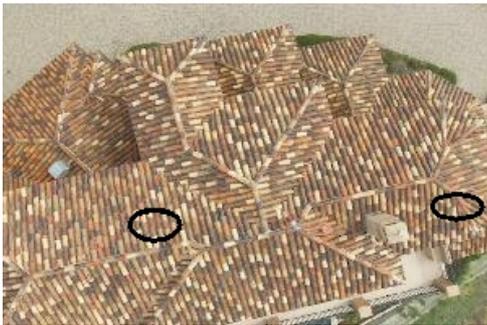
3.6 - DEFICIENT: There are a number of tiles or mortar that are not secured and have slipped. We recommend that you have the roof covering evaluated by an appropriately qualified specialist for further remarks and recommendations.

3.6 -- DEFICIENT: A number of tiles/mortar have slipped

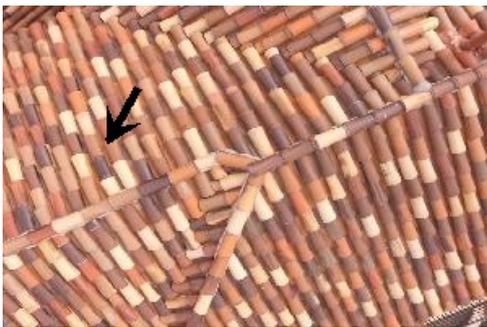
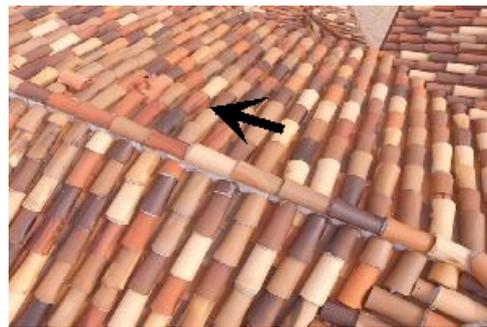
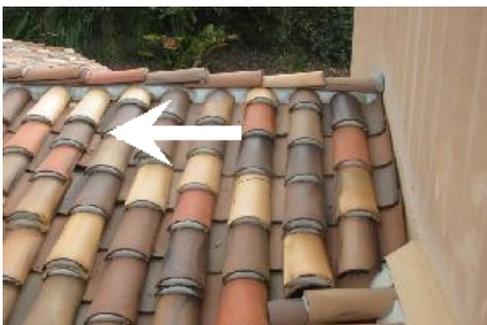
3.8 - COMMENTS: There are several cracked or chipped tile, but none that are large enough to warrant replacement of the tile.

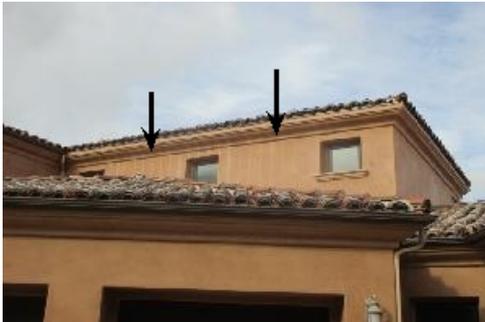
3.13 - PREVENTIVE: Gutters and downspouts have not been provided at all areas of the roof. However, because poor site drainage can damage the structure and foundation and lead to moisture intrusion, serious consideration should be given to the installation of a complete system for drainage of rainwater away from the residence and its foundation.

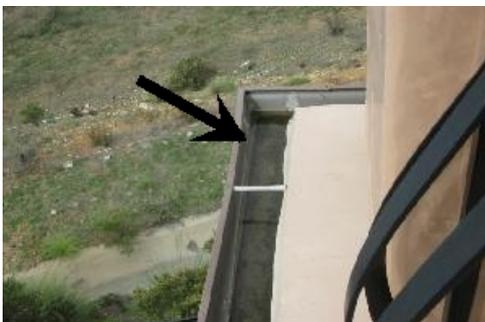
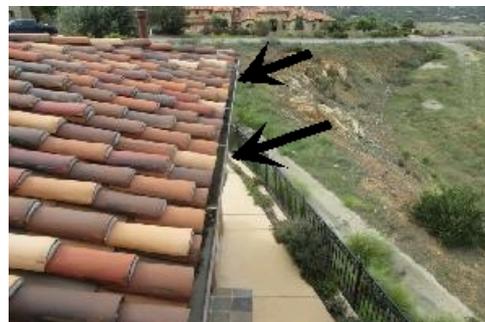
3.15 - MAINTENANCE: The roof gutters need to be cleaned and serviced to perform properly.

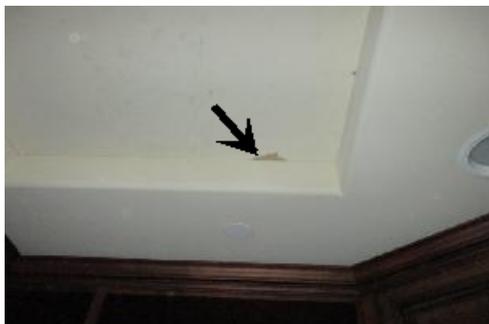
4.5 - DEFICIENT: The attic access hatch in the master bedroom closet is broken and should be replaced or repaired.

4.5 -- DEFICIENT: Attic access hatch broken or missing

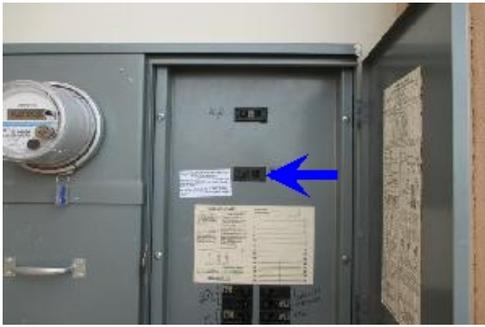
5.4 - COMMENTS: The 200 amp main disconnect is located inside the main panel.

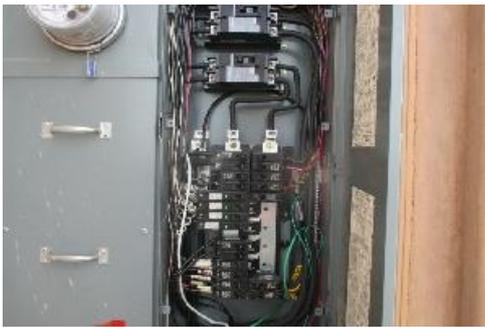
5.7 - COMMENTS: The residence is served by what appears to be a 400 amp panel, located at the north side of the residence.

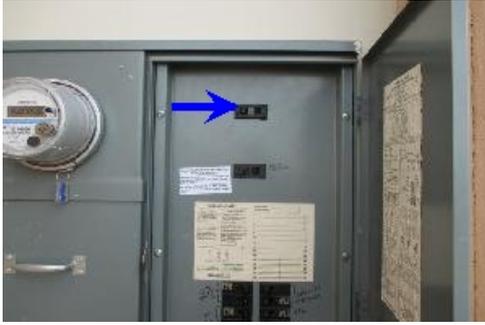
5.12 - COMMENTS: The 90 amp sub disconnect is located inside the main panel.

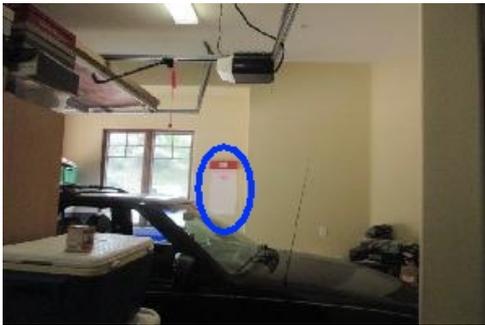
5.15 - COMMENTS: There is a 200 amp sub panel located in the garage

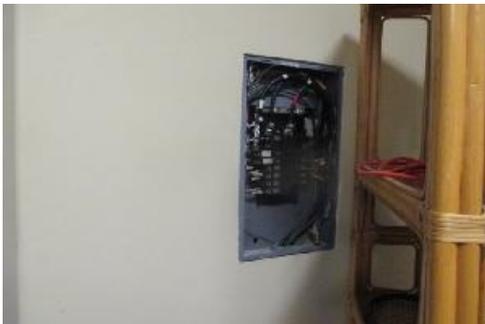
5.17 - COMMENTS: There is a 125 amp sub panel located in the garage (2nd Garage)

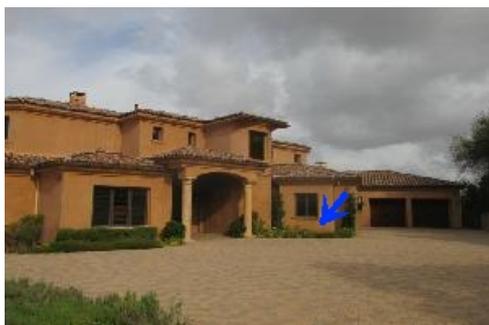
6.3 - COMMENTS: The water main shut off valve is located at the south side of the home.

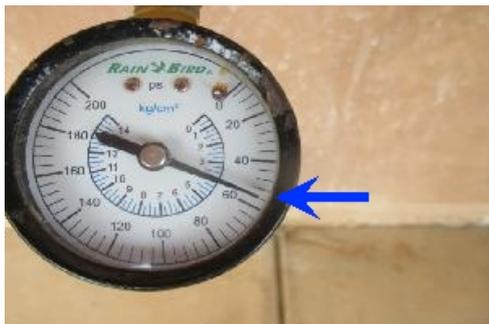
6.4 - COMMENTS: A water pressure regulator was in place on the main water line. Internal water pressure was 60 psi at the time of the inspection, which is acceptable.

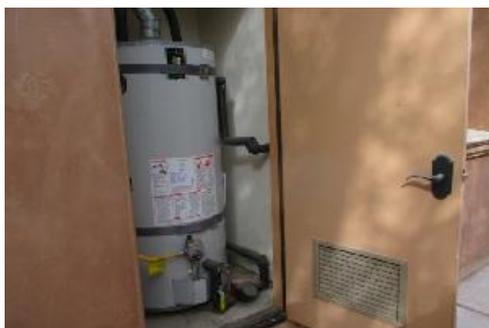
6.20 - COMMENTS: There is a 7 year old, 75 gallon, BRADFORD WHITE natural gas water heater located at the south exterior.

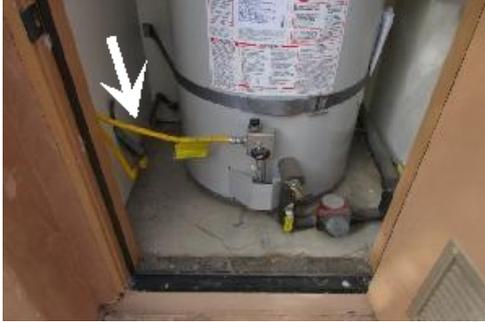
6.29 - PREVENTIVE: There is no gas line drip leg sediment trap on the water heater gas supply line. One should be installed by an appropriately qualified specialist.

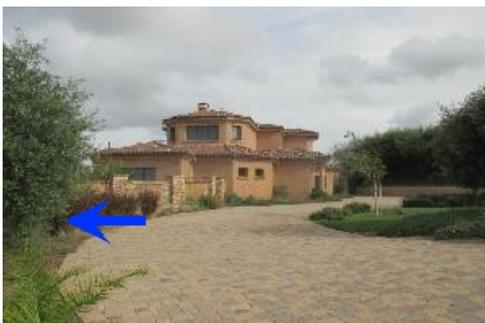
6.36 - COMMENTS: The gas shut-off valve is located at the gas main.

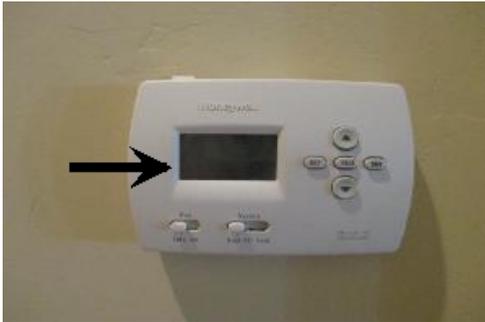
7.1 - DEFICIENT: The thermostat was not functioning at the time of inspection. Without a properly functioning thermostat the HVAC system could not be fully inspected.

7.1 -- DEFICIENT: Thermostat not functioning

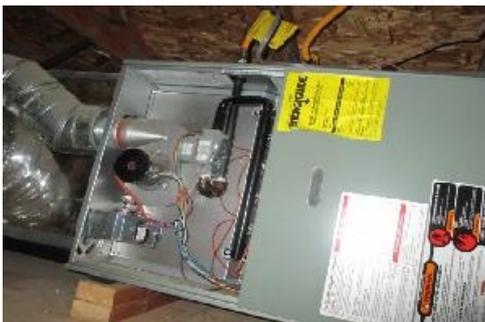
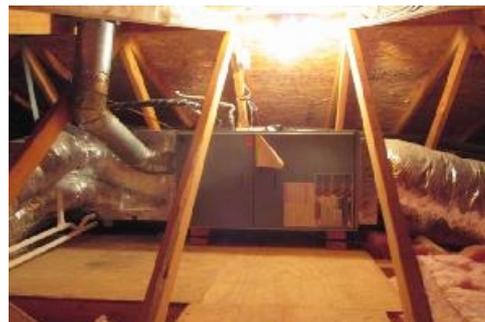
7.5 - DEFICIENT: The 1st and 2nd 8 year old, 100,000 btu RHEEM gas-fired forced air heating units failed to respond to normal user controls at the time of the inspection and they will need to be evaluated by an appropriately qualified specialist for further remarks and recommendations. The units is located in the 2nd floor and east 1st floor attic.

7.5 -- DEFICIENT: Forced air heating units failed to respond

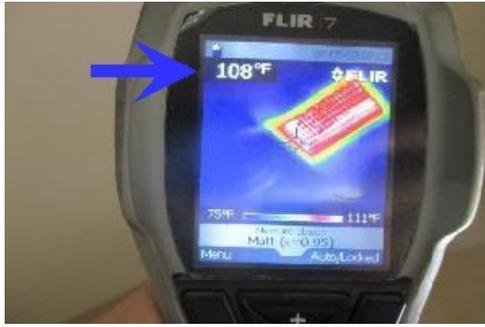
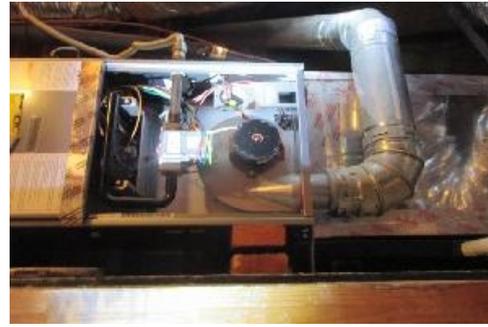
7.6 - COMMENTS: The 9 year old, 50,000 btu RHEEM gas-fired forced air heating unit is located in the attic. The furnace responded to normal user controls at the time of the inspection. (Third Unit)

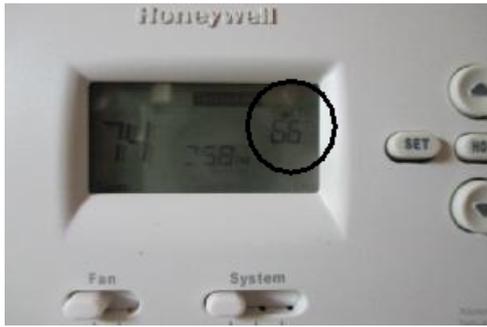
8.1 - DEFICIENT: The split-systems central cooling did not respond to normal there user controls at the time of the inspection. It is suggested that the unit be further evaluated by a HVAC professional.

8.1 -- DEFICIENT: Cooling system did not respond to user controls

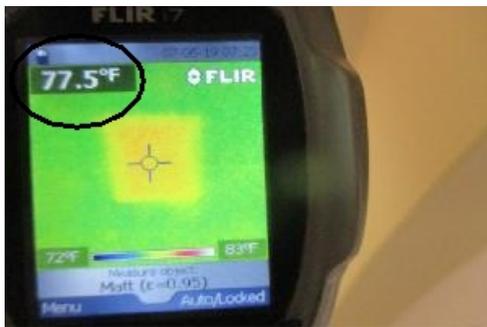
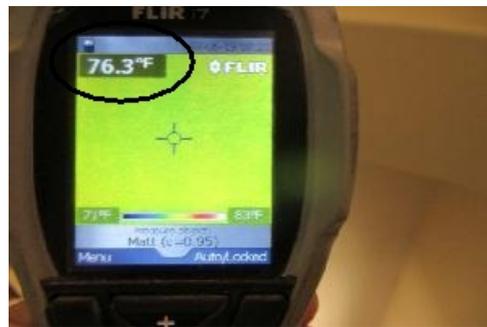
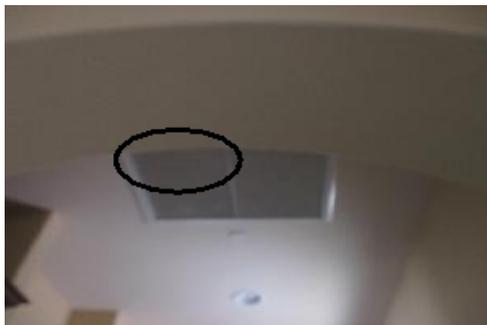
8.2 - DEFICIENT: The 14 degrees differential temperature split between the air entering the system return and that coming out of the registers is inadequate, and an indication that the system is in need of servicing.

8.2 -- DEFICIENT: No appreciable difference in temperature split

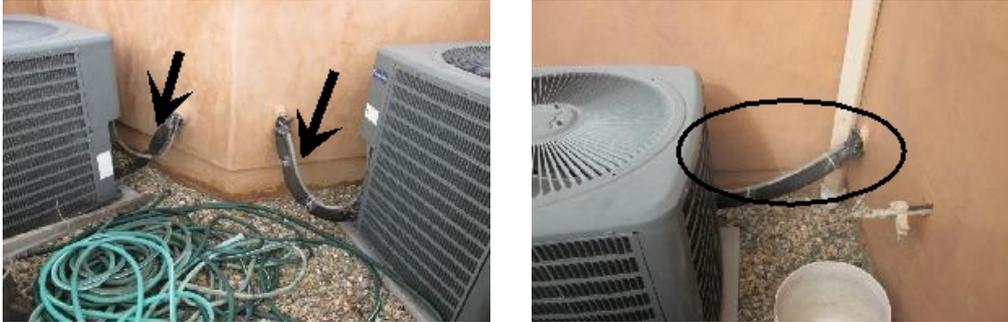
8.10 - PREVENTIVE: The Refrigerant lines need to be wrapped with insulation to prevent condensation build-up on the lines. This will help prevent further corrosion of the furnace and its components.

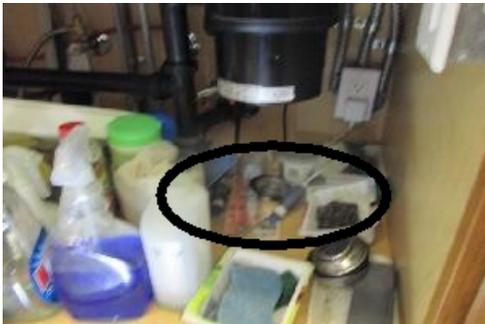
10.7 - DEFERRED: Water stains were found at the bottom shelf of the kitchen sink cabinet which could be evidence of an existing water leak.

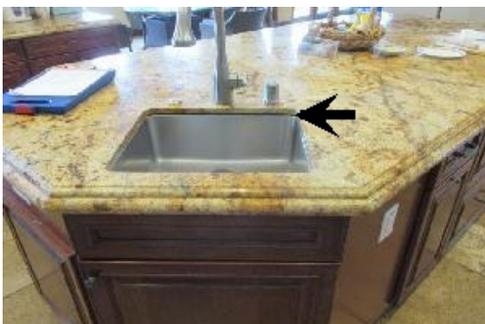
10.11 - PREVENTIVE: Caulking is needed around the kitchen sink to prevent potential (or further) water intrusion into the sink cabinet and adjacent areas.

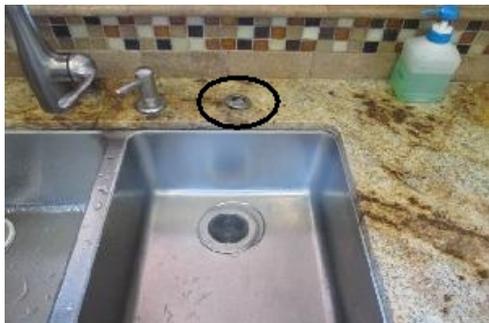
10.12 - DEFICIENT: The garbage disposal switch is loose or damaged.

10.12 -- DEFICIENT: Garbage disposal switch is loose

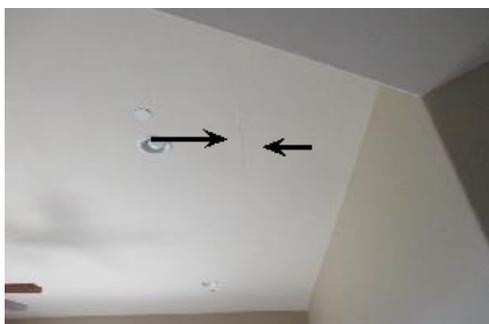
12.3 - DEFICIENT: The ceiling of the bedroom has some damage that is in need of repair.

12.3 -- DEFICIENT: Damage to ceiling

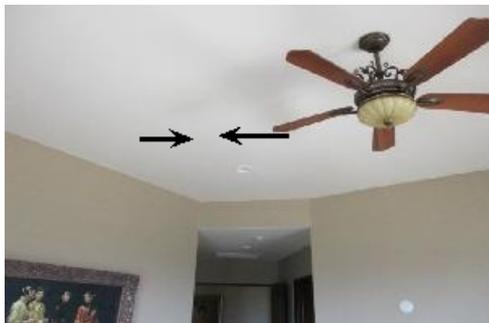
12.4 - COMMENTS: There are hairline cracks in the ceiling of the bedroom that do not appear to be structurally significant.

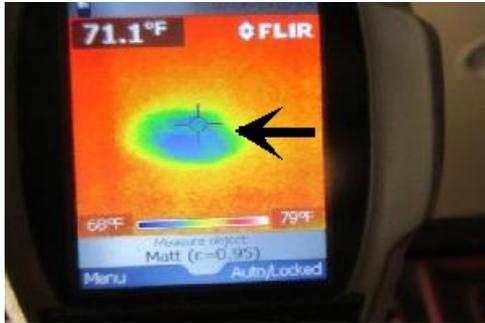
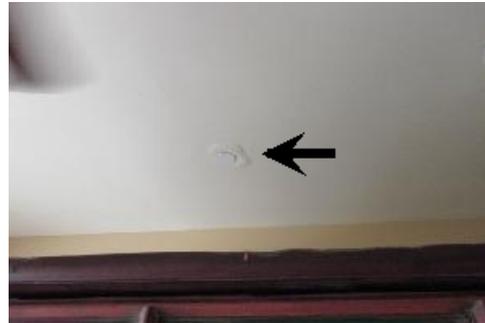
12.36 - DEFICIENT: There is moisture intrusion in the bedroom ceiling around the fire sprinkler system.

12.36 -- DEFICIENT: Moisture intrusion at bedroom ceiling

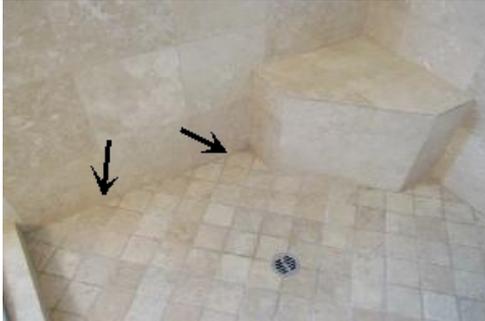
13.25 - PREVENTIVE: There are open grout-joints in the tiles of the bathroom shower stall that should be sealed to prevent moisture damage.

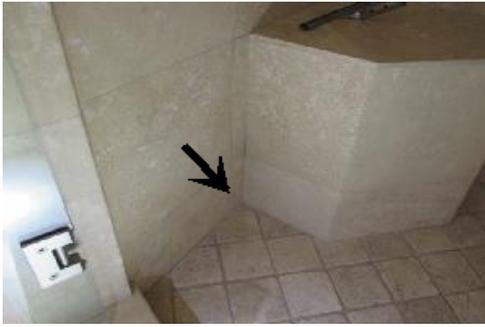
13.51 - DEFICIENT: There are cracked or chipped tiles in the bathroom shower stall which should be repaired or replaced to forestall moisture intrusion.

13.51 -- DEFICIENT: Cracked tiles in shower stall

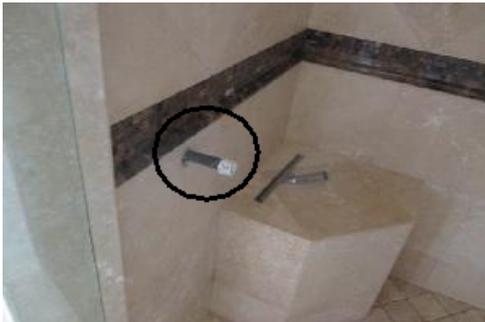
13.52 - PREVENTIVE: There are areas of surface damage in one or more walls of the bathroom shower stall walls that will need to be repaired to help prevent water entry/damage.(unknown unsealed pipe)

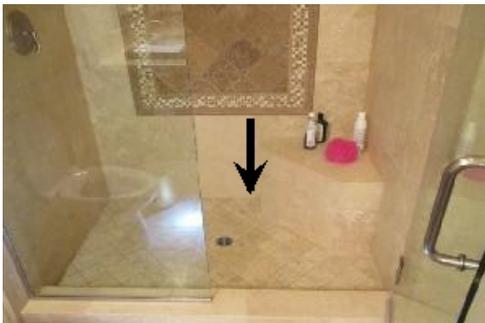
13.73 - PREVENTIVE: There are open grout-joints in the tiles of the bathroom shower stall that should be sealed to prevent moisture damage.

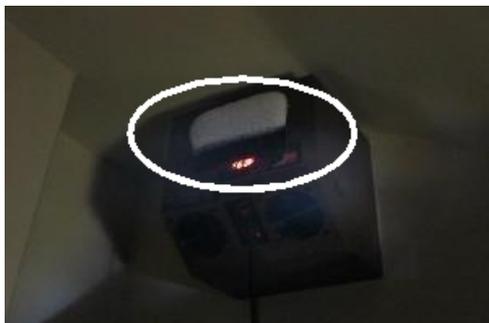
15.17 - DEFICIENT: The cooler fan in the pantry/wine cellar is leaking and needs to be serviced to prevent moisture damage.

15.17 -- DEFICIENT: The pantry cooler fan is leaking

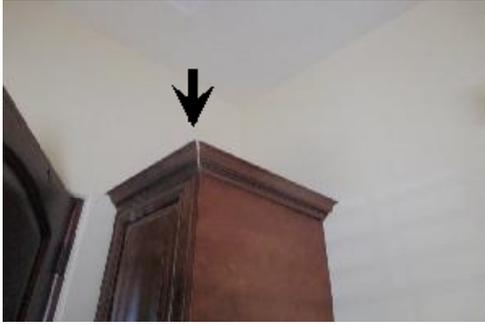
15.18 - DEFICIENT: The laundry room cabinetry is damaged and will need repair or replacement.

15.18 -- DEFICIENT: Cabinetry is damaged

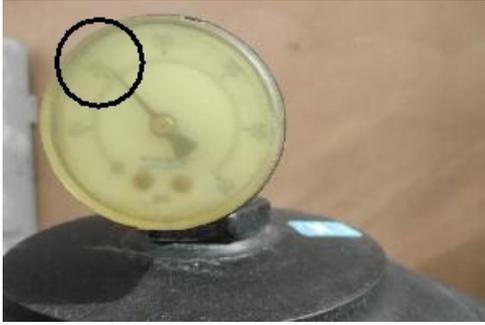
18.9 - DEFICIENT: There is an excessively high pressure reading on the filter gauge that will need to be evaluated by an appropriately qualified specialist for further remarks and recommendations.

18.9 -- DEFICIENT: High pressure reading on pool filter gauge

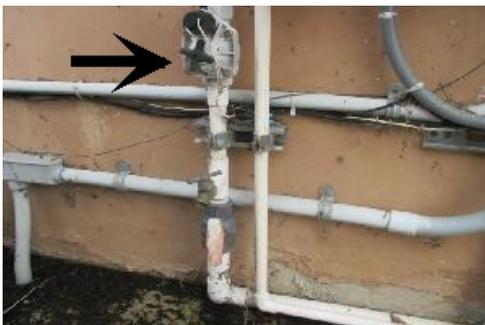
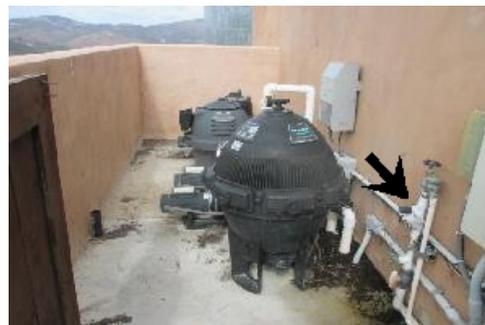
18.17 - DEFICIENT: There is a leak at the fill valve that needs to be serviced.

18.17 -- DEFICIENT: Leak at water fill line valve
