HOME INSPECTION REPORT

For The Property Located At
123 Elm st, San Diego, CA 91977

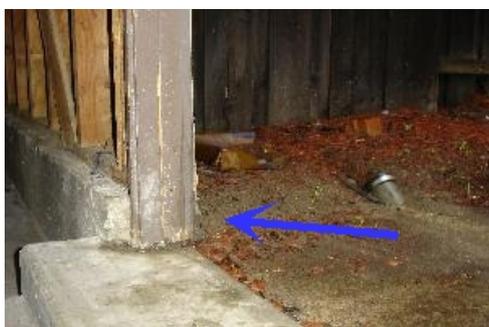
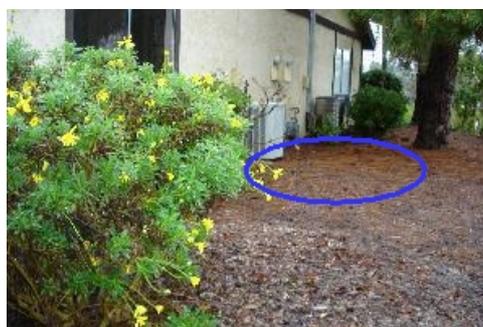
1.1 - PREVENTIVE: The soil is not sufficiently sloped or graded to drain runoff water away from the multiple locations around the residence. Inadequate drainage and grading around a building can lead to moisture intrusion and create an environment conducive to the growth of mold. It can also damage the foundation and/or cause excessive settlement. As a preventive measure we recommend that the soil be sloped to drain surface water away from the residence for ten feet or more and/or that hardscaping be installed, and/or that an appropriate drainage system be provided.

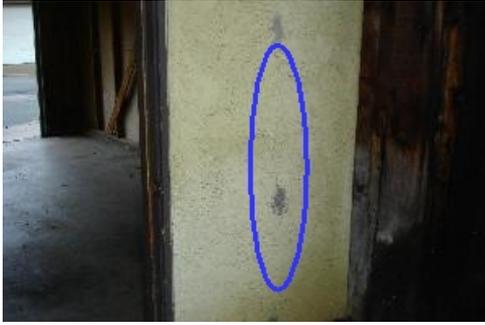
1.6 - DEFICIENT: The stucco wall coverings at the the west side of the detached garage are damaged and need repair.

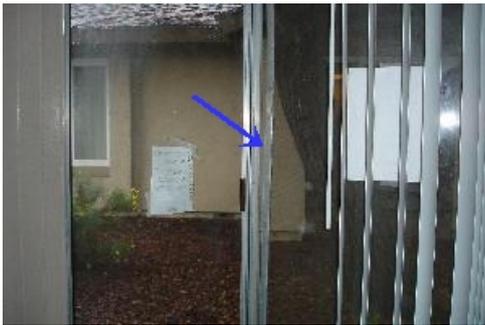
1.9 - DEFICIENT: There is a damaged window screen at the south side of the home that you may wish to have repaired.

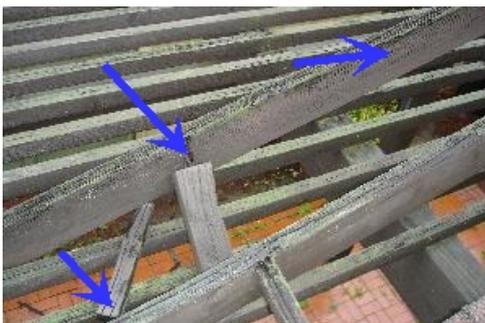
1.12 - DEFICIENT: The homes attached pergola shows minor signs of decay this should further evaluated by a pest control technician to determine if it is caused by wood destroying pests. If you have not yet had a termite inspection it is highly advised that you do.

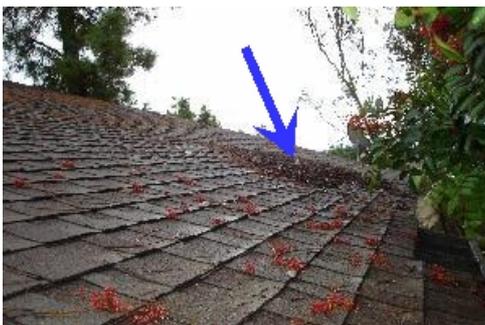
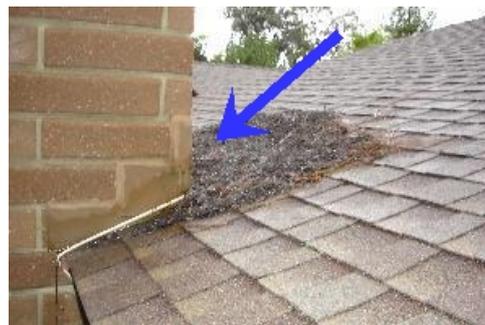
3.2 - MAINTENANCE: There are leaves or debris in some of the valleys that need to be cleared off to help prevent premature deterioration of the coverings and to facilitate drainage.

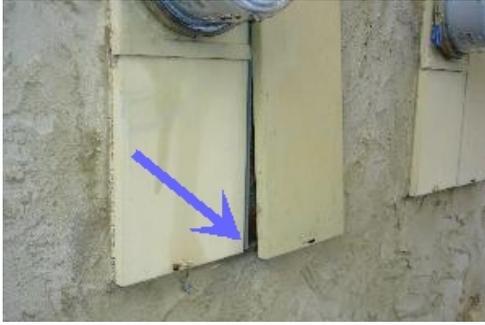
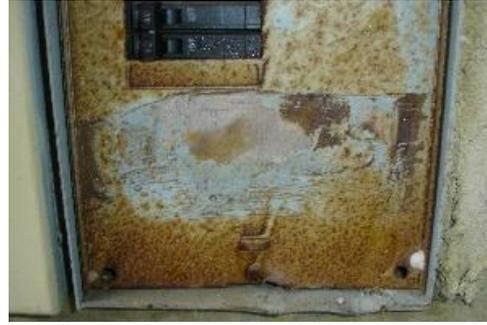
5.4 - DEFICIENT: The exterior cover for the main electrical panel rusted and will need to be serviced by an appropriately qualified specialist.

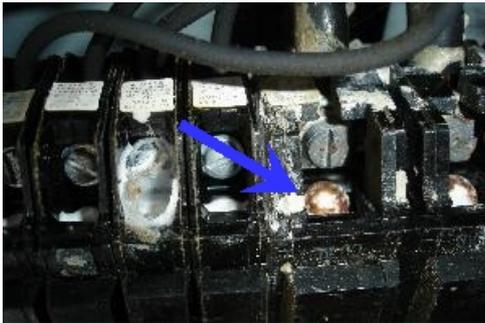
5.5 - DEFICIENT: One or more of the main panels circuit breakers is corroded and should be further evaluated by a professional.

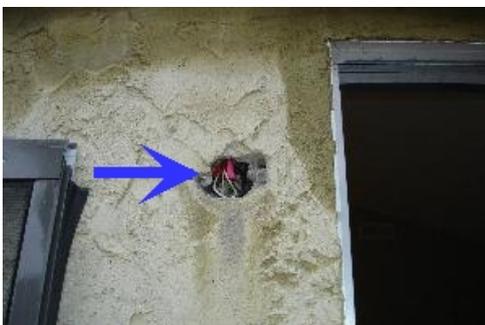
5.8 - DEFICIENT: There is an open electrical junction box at the the east side of the residence which should be sealed so that any arching or sparking would be contained within the box, and to help keep moisture out.

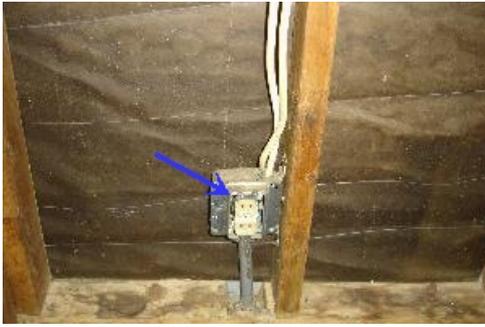
5.9 - DEFICIENT: There is an open electrical junction box at the east side of the garage that should be sealed so that any arching or sparking would be contained within the box, and to help keep moisture out.

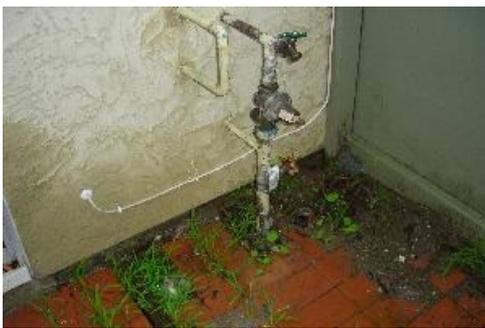
6.1 - COMMENTS: Where exposed to view, the water main entering the home is 3/4 inch copper. The supply line enters at the east side of the residence.

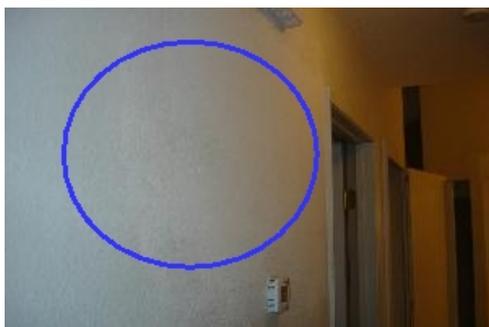
8.1 - DEFERRED: There is evidence of patching to the main entry way wall. You may want to make further inquiry of the seller regarding this condition.

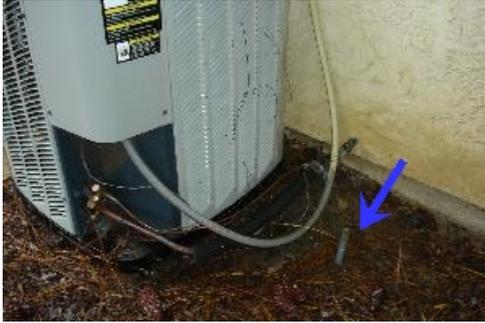
9.2 - MONITOR: The homes watering system is close to condensing unit. This may lead to future corrosion of the unit this should be monitored.

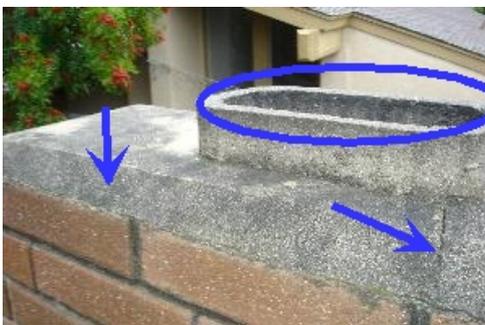
10.5 - DEFICIENT: The chimney crown, which is designed to seal the chimney wall and shed rainwater, has one or more cracks that should be sealed to help prevent moisture intrusion.

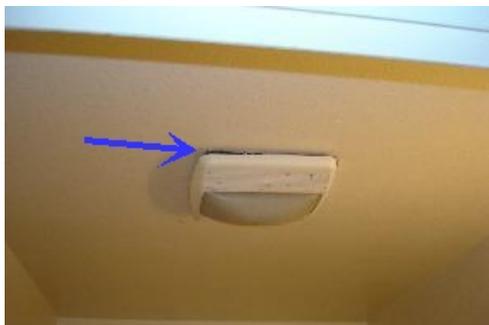
13.14 - DEFICIENT: The cover for the bathroom exhaust fan is missing or damaged and needs replacement or repair.

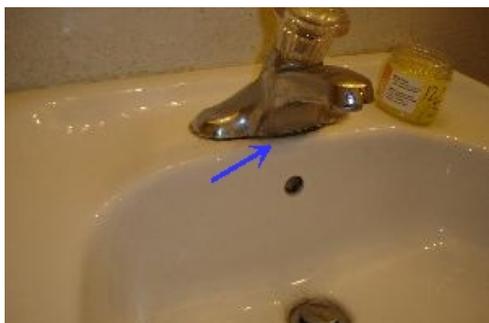
13.16 - DEFICIENT: One or more of the faucet valve handles at the bathroom sink is rusted or corroded and needs replacement.

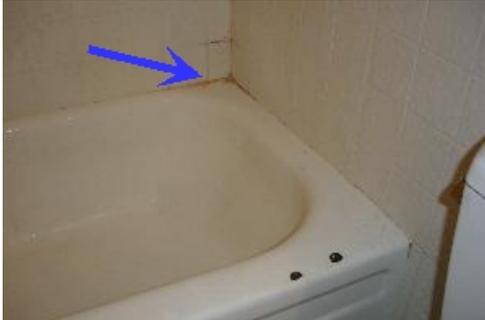
13.18 - PREVENTIVE: There are one or more chips in the bathtub that will need to be repaired to help prevent moisture intrusion.

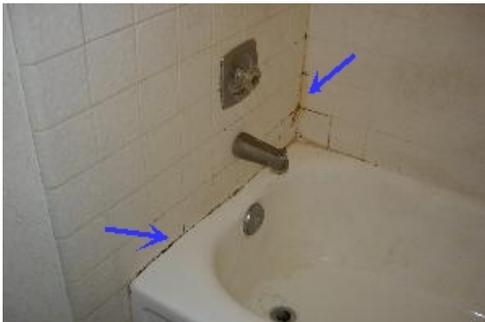
13.20 - PREVENTIVE: Caulking is needed in and around the bathroom shower to prevent potential (or further) water intrusion into the sub-floor and walls of the bathroom.

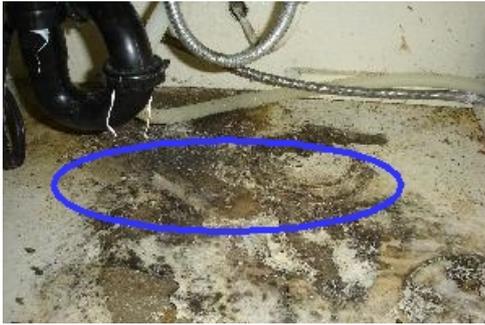
14.6 - DEFICIENT: There is moisture damage to the bottom shelf of the kitchen sink cabinet that requires service.

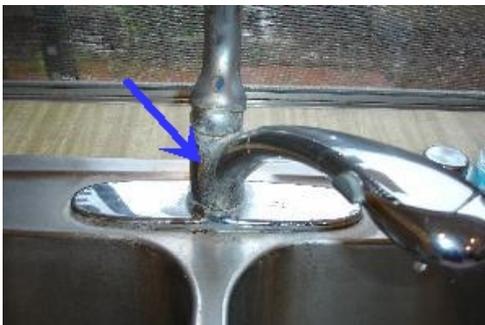
14.7 - DEFICIENT: The kitchen sink faucet is corroded.

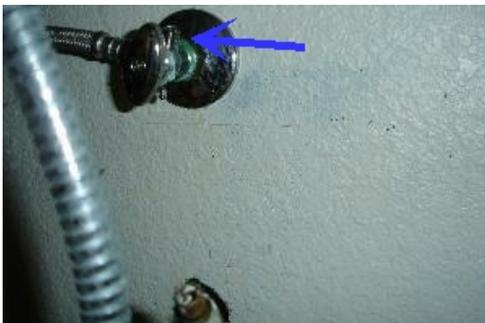
14.8 - DEFICIENT: Leakage was found at the cold water shut-off valve(s) under the kitchen sink.

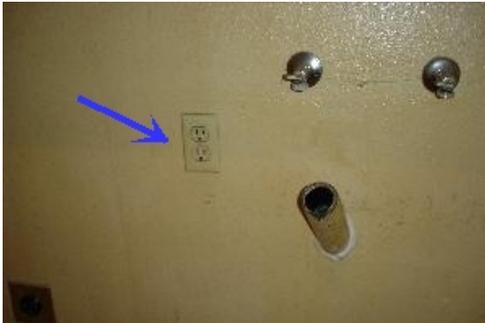
15.4 - DEFICIENT: One or more outlets in the laundry room are loose and need to be repaired.

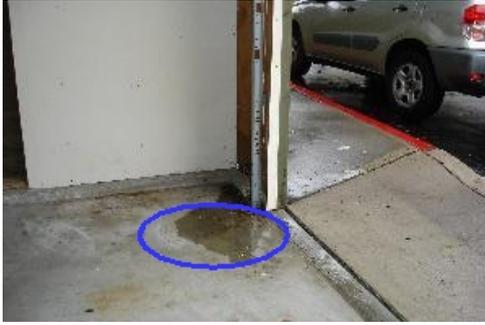
16.1 - DEFICIENT: There is evidence puddling water on garage floor. This appears to be coming from the outside it is suggested that it be further evaluated to determine its source and proper repairs should be made.

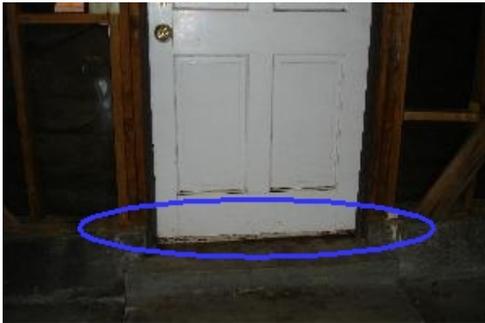
16.2 - DEFICIENT: There is a large gap at the base of the garage side door which should be serviced to help prevent moisture and pest intrusion, to reduce drafting and for improved energy efficiency.
