Confidential Inspection Report

LOCATED AT:
123 Elm St
San Diego, California 92120

INSPECTED ON:
Friday, July 3, 2020

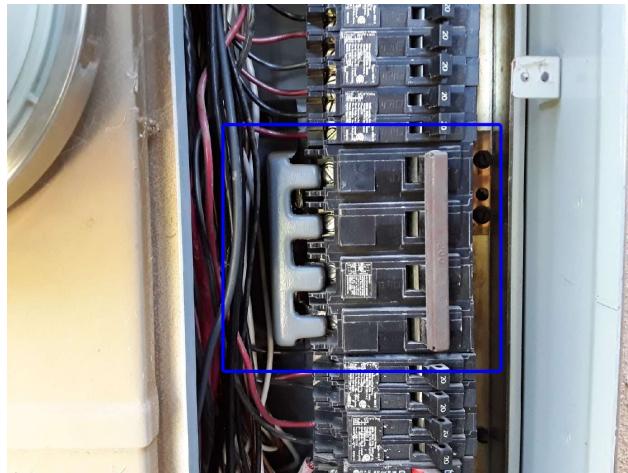
MAIN DISCONNECT

100: The main disconnect is incorporated into the electrical service panel.

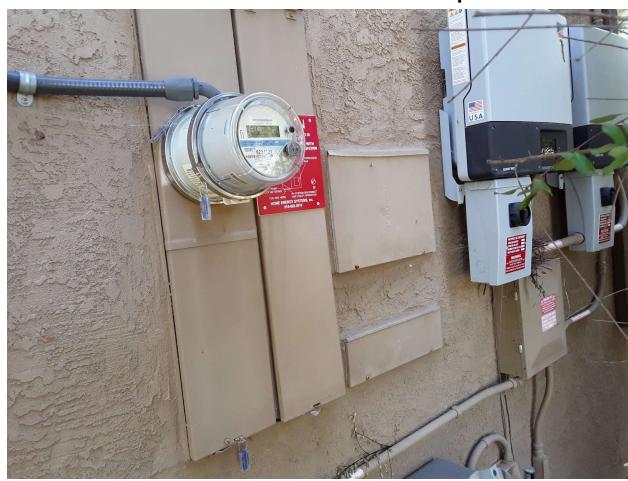
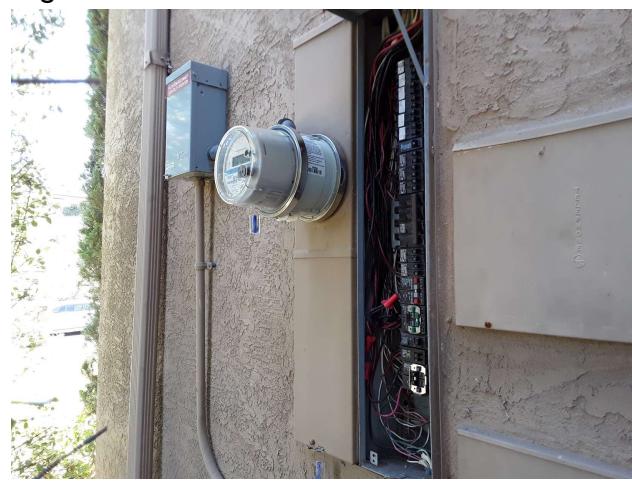
103: PANEL: The main electric panel is located right side exterior.

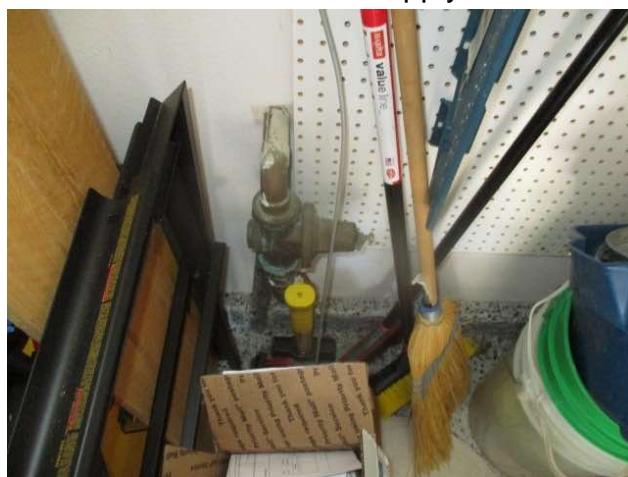
WATER SHUTOFF LOCATION

128: The domestic water supply shut-off valve is in the garage.

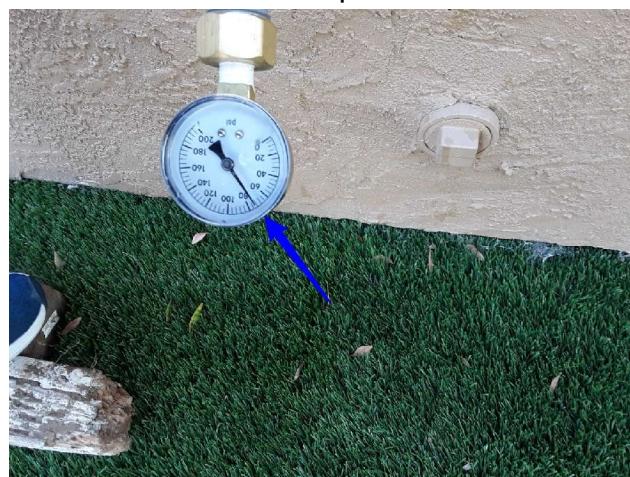
WATER PRESSURE

133: The homes water pressure measured 80 PSI (pounds per square inch).

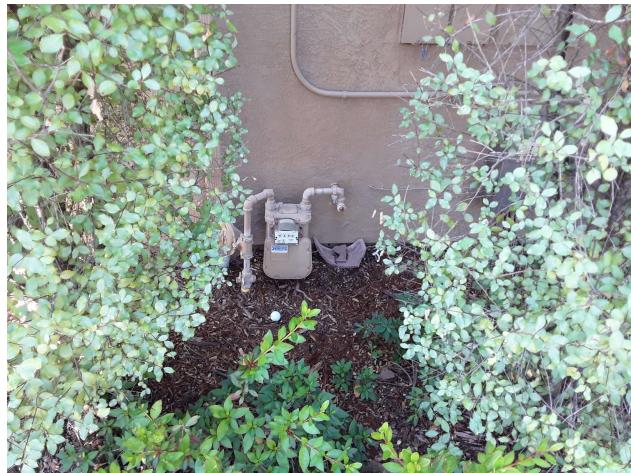
GAS METER LOCATION

142: The gas meter is outside on the right side of the building. The main gas supply shutoff valve is located on the riser pipe between the ground and the meter. This valve should be turned 90 degrees (either way) in order to shut off the gas.

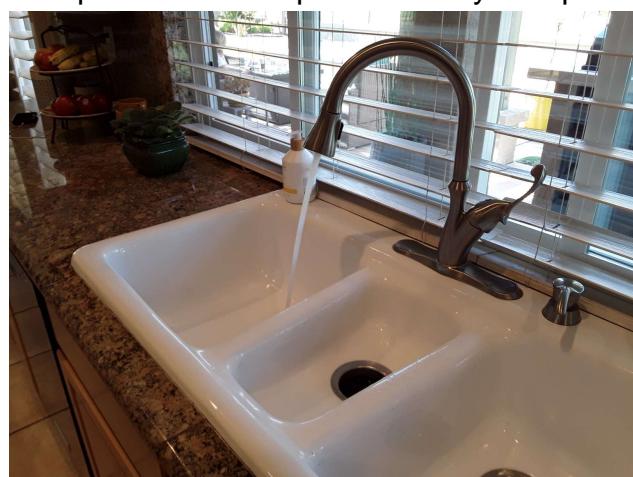
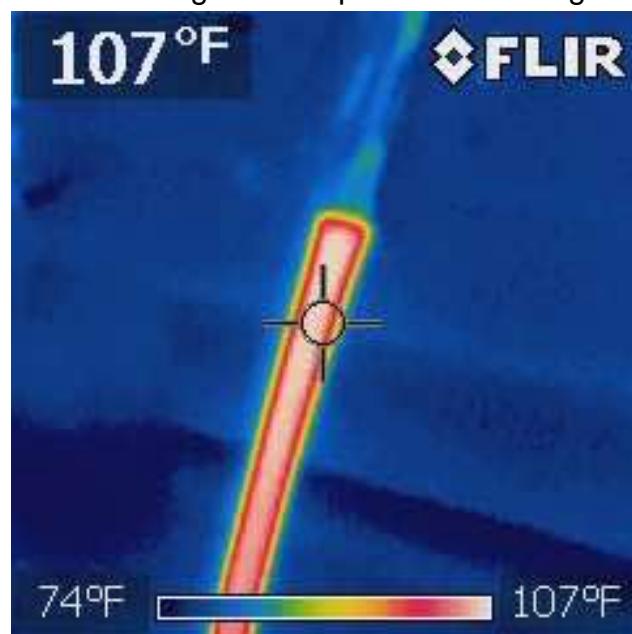
146: The water temperature coming out of the kitchen faucet measured 107 degrees which is an acceptable safe temperature. Any Temperature over 126 degrees is a potential scalding hazard.

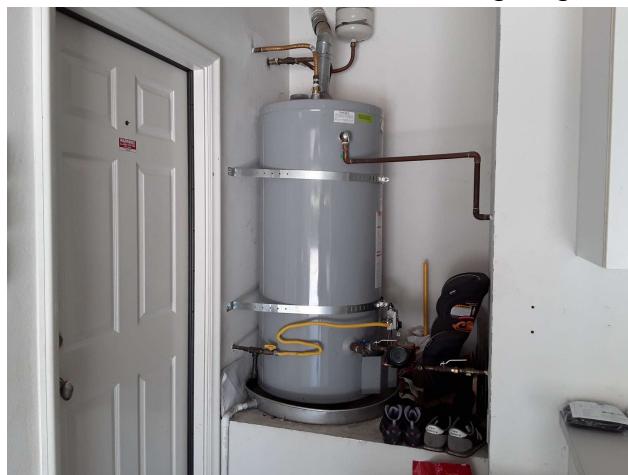
149: LOCATION: Location: In the garage

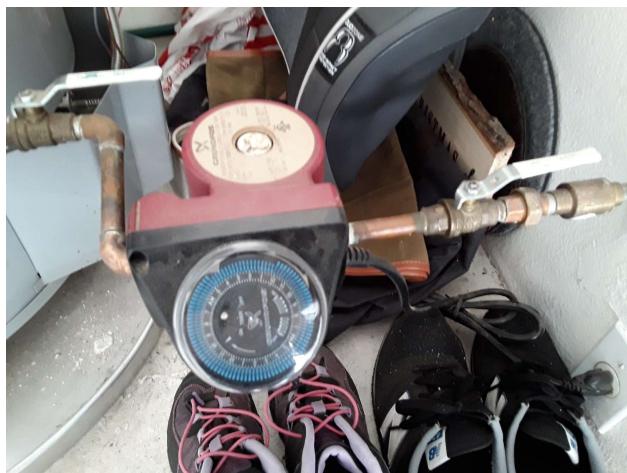
RECIRCULATING

173: The hot water recirculating system is a beneficial feature but there are energy costs associated with this convenience. We do not review or inspect these systems.

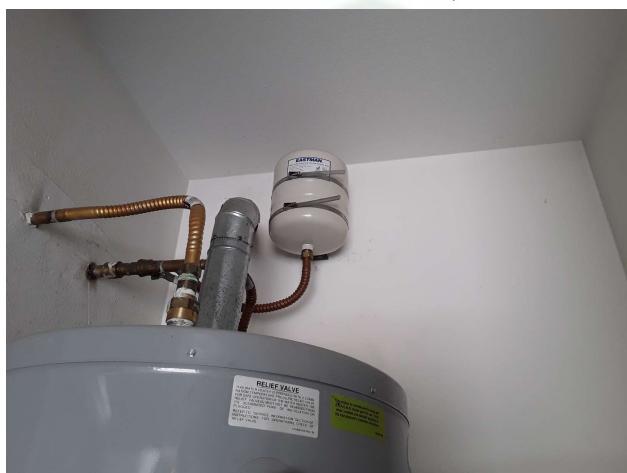
EXPANSION TANK

174: The water heater is equipped with an expansion tank that appears properly installed and in serviceable condition. However, review of this equipment is beyond the scope of this inspection.

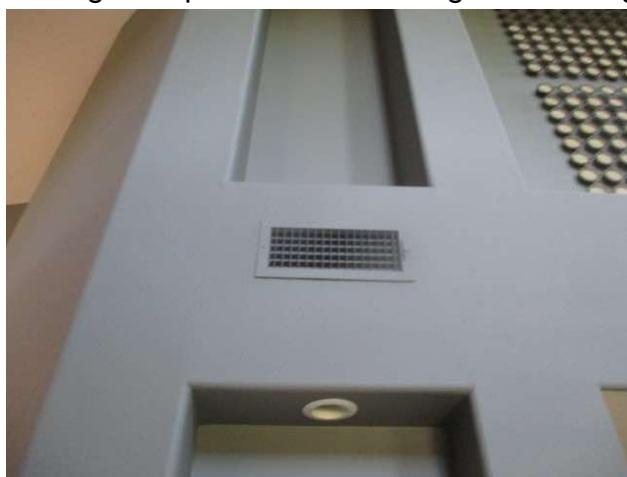
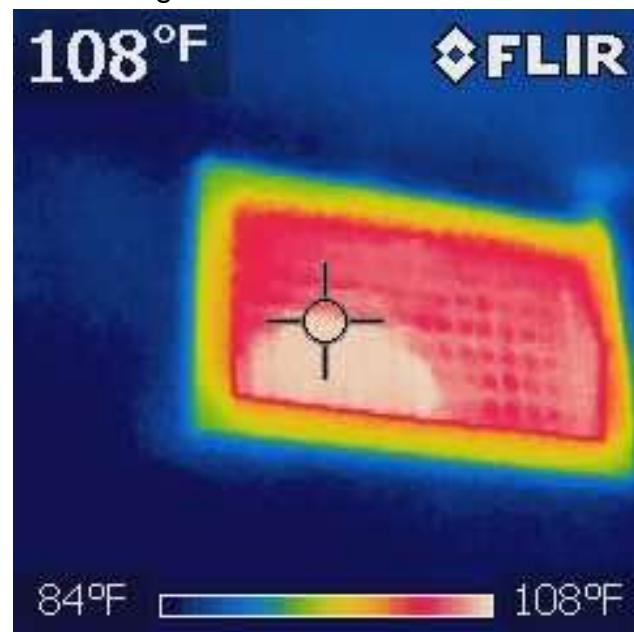
182: The heating system responded to normal user controls at the time of inspection. With an average temperature of 108 degrees coming out of the register vents.

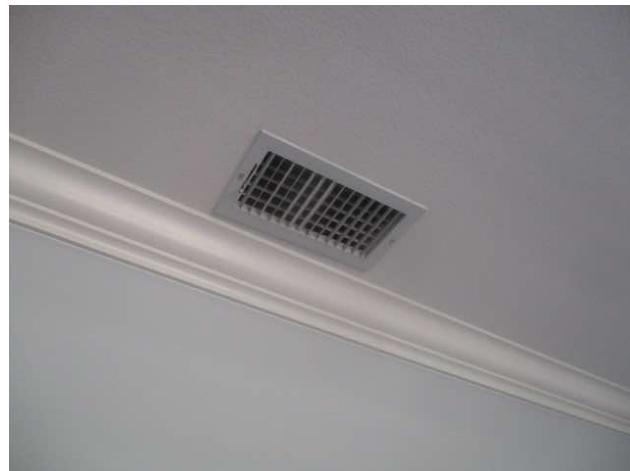
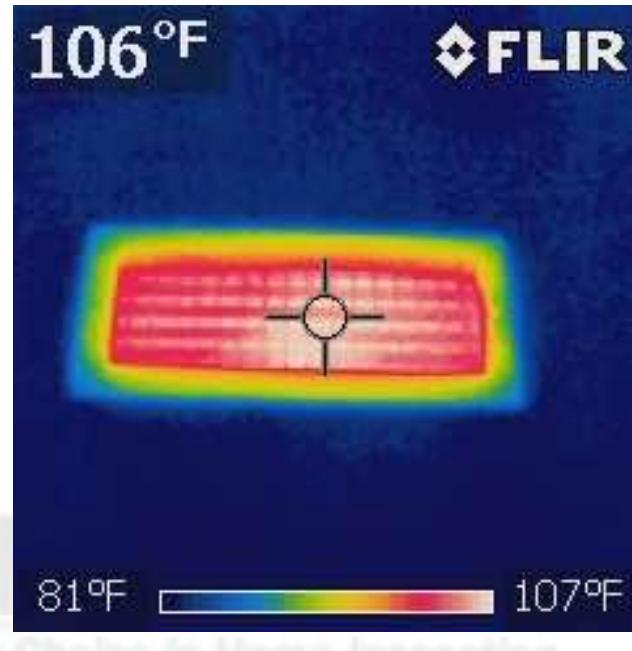
204: The heating system responded to normal user controls at the time of inspection. With an average temperature of 106 degrees coming out of the register vents.

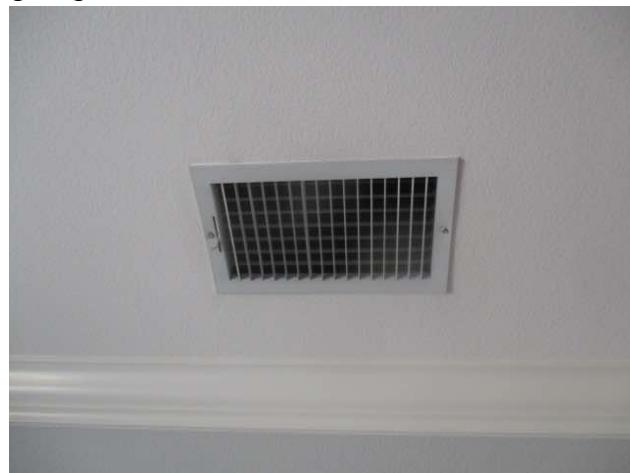
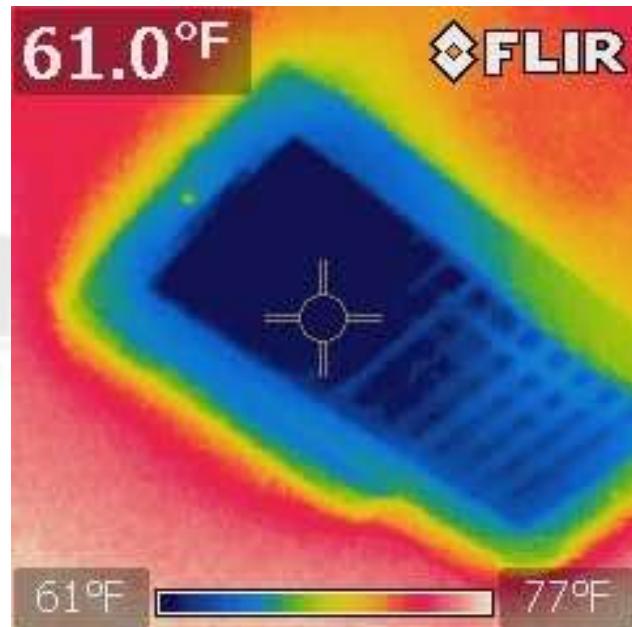
268: The air conditioning system responded to normal user controls at the time of inspection. With an average temperature split of 18 degrees air coming out of the register vents and air going into the return.
